Baton Rouge Lake Dredging Project

A Cleaner Method for Removing and Dewatering Sediment

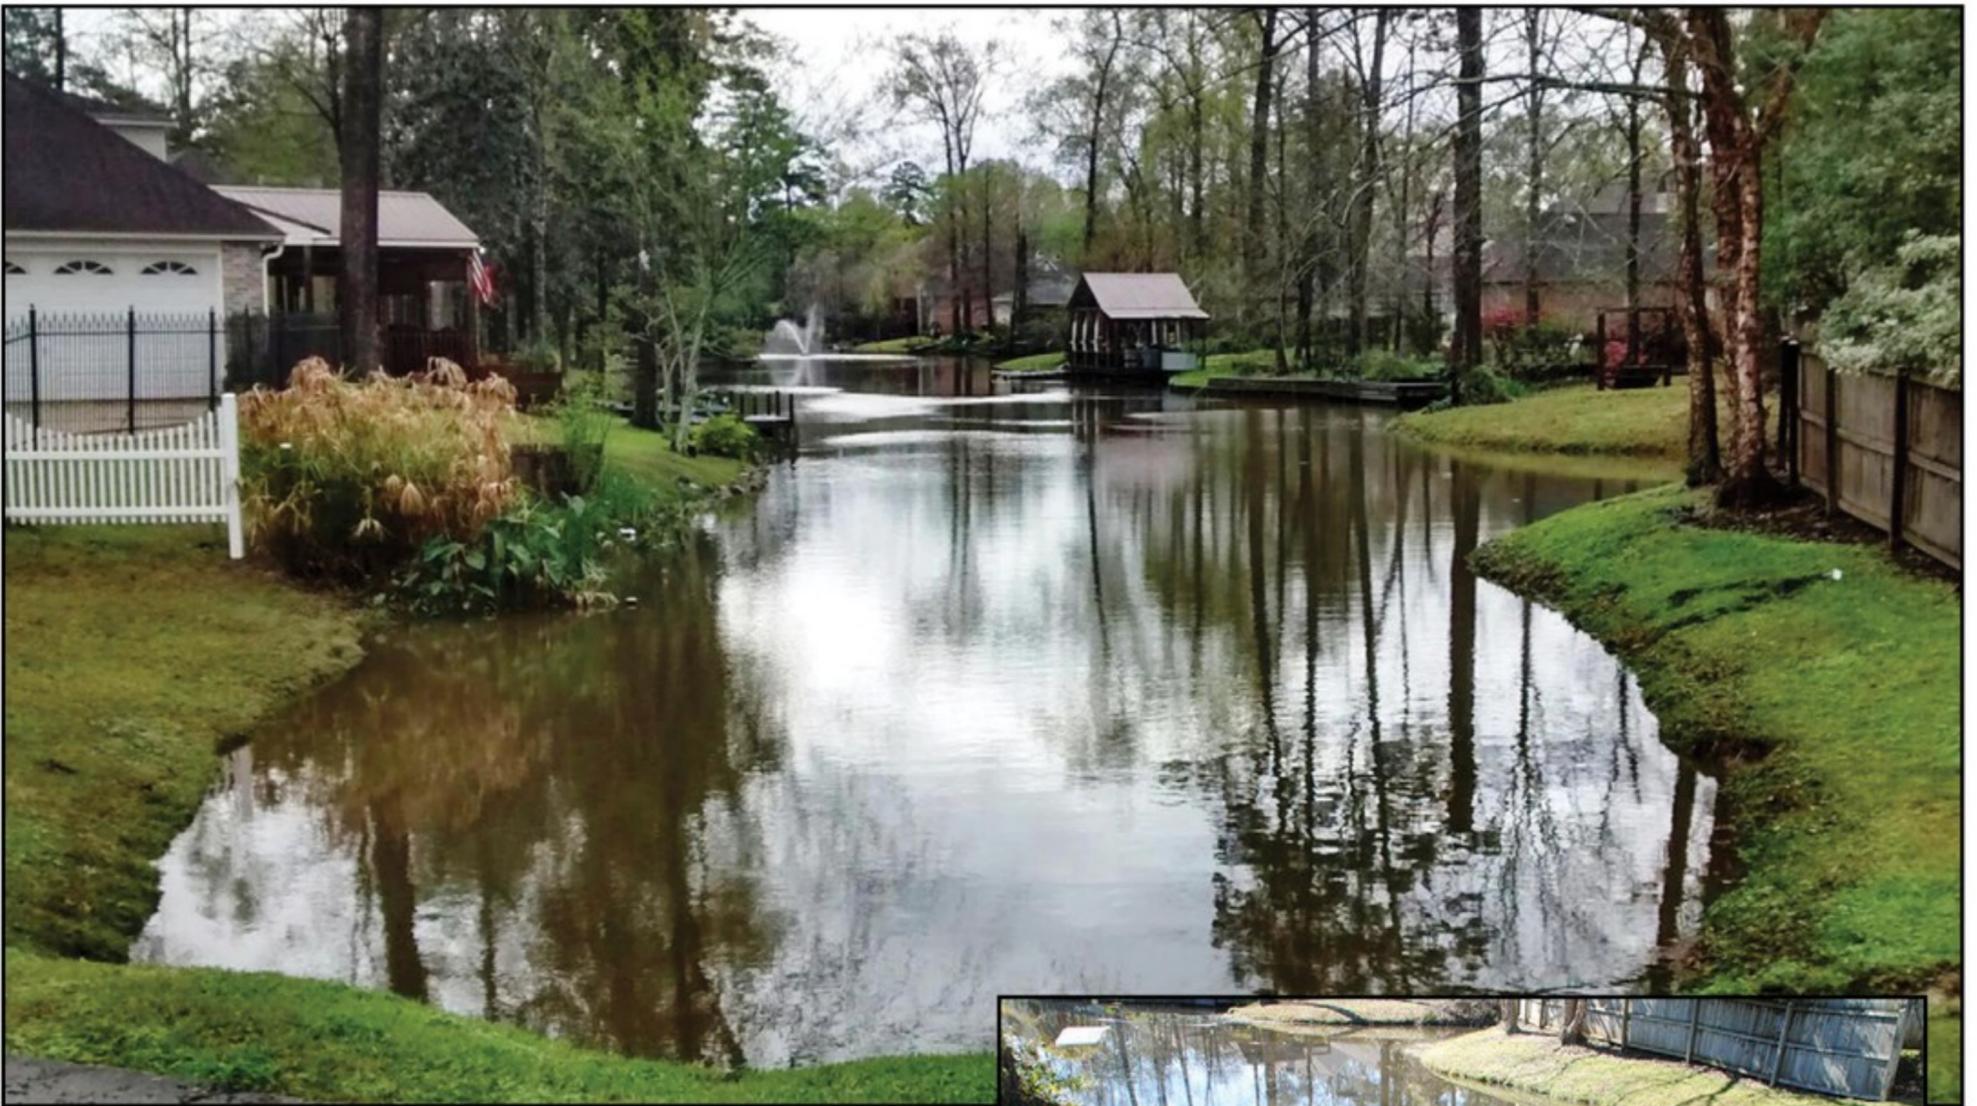
Above: Day 1 after project completion. Inset: Picture taken during initial site inspection shows visible accumulation of sediment and organic debris.

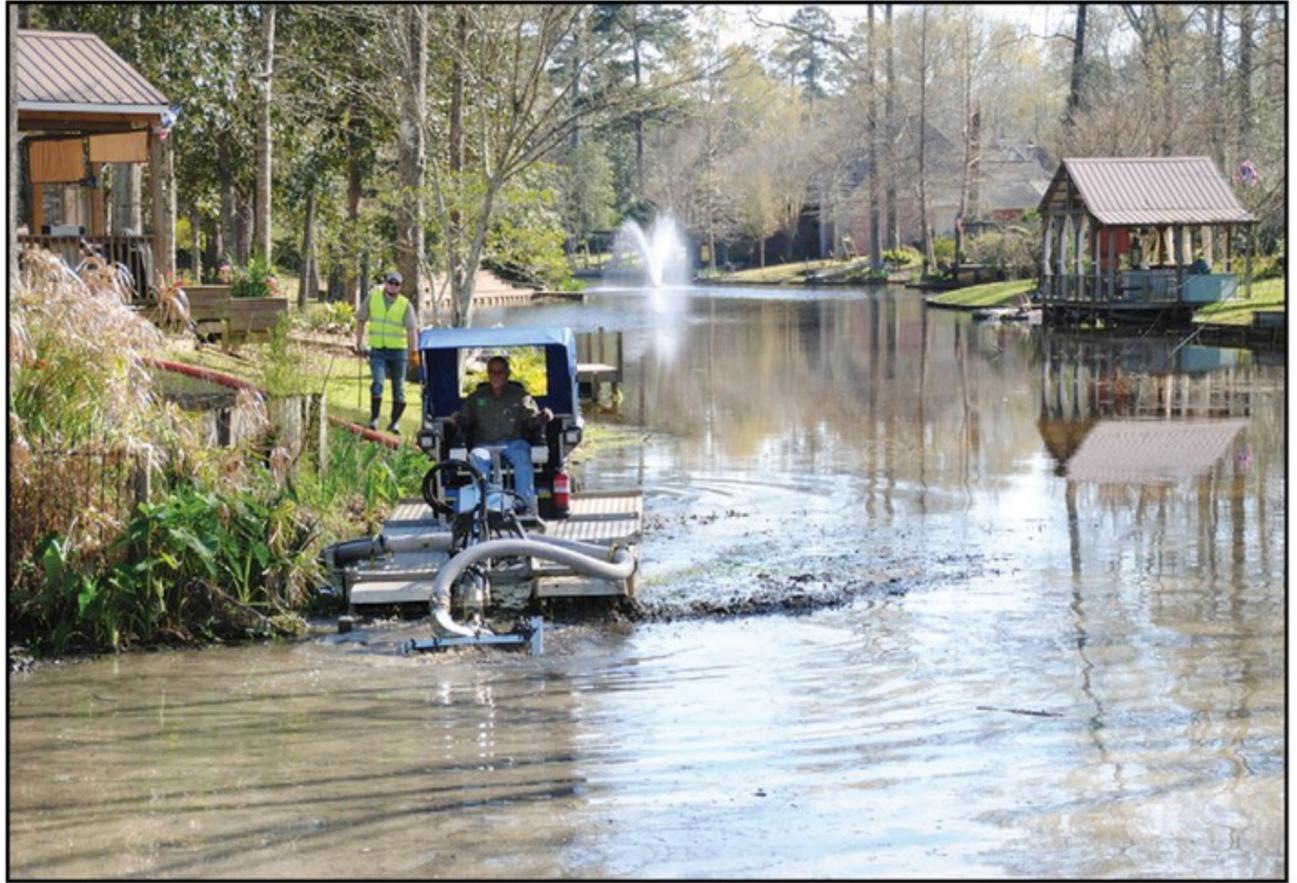
Amphibious dredge running on top of accumulated sediment.

Ultimately, an amphibious dredge manufactured in Sweden with a 4" submersible pump mounted to a 3 foot auger head was selected for this project. The dredge pump operates around 500 GPM producing approximately 30% solids with a maximum dredging depth of eight feet (which is perfect for this shallow lake), and can operate in as little as six inches of water (another advantage considering the depth of sediment accumulation). Not only was the pump size a good choice for the project, but the amphibious machine was

driven off of the trailer onto the street, then driven down the shoreline directly into the water with no disturbance to the asphalt or the grass along the shoreline slope. The amphibious design of this machine was great for accessing the lake, and with a zero-radius turn capability, for getting the dredge pump into hard to reach places.

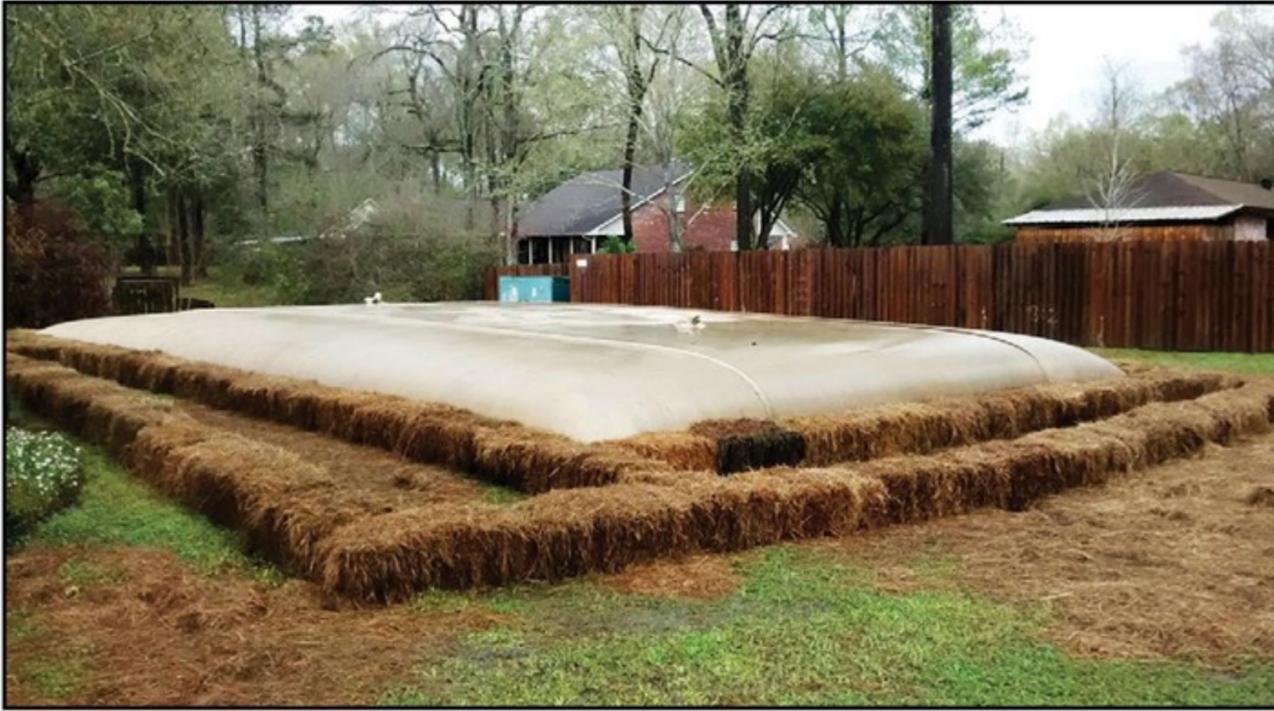
Geotextile bag contains the sediment as it is removed from the lake.

Once the dewatering area was leveled, a three foot high temporary containment pool was constructed using straw bales and poly sheeting to contain the filtered water from the geotextile tube. A 60' circumference x 50' long geotextile tube was then placed inside the containment pool, leaving approximately five foot of available space on each side for water containment. A dual hose bridge was then constructed across the community street to allow vehicles to travel safely across the dredge discharge hose and return water hose. A 3" gas powered water pump was setup to pump the filtered water

A 60' circumference geotextile tube has an approximate volume capacity of 5.5 cubic yards per linear foot based on sand giving a total volume capacity of 275 cubic yards with the 50' tube length. There is, of course, no reduction in sand volume during the dewatering process (1:1) as opposed to the approximate 50% shrink rate estimated for the fine silts, organic sediments and "lake muck" removed during this project. The 60'x50' geotextile tube was filled to maximum capacity in approximately 4 days (approximately 24 pumping hours). The high percent solids and low GPM obtained with the 4 inch submersible dredge pump greatly assisted in the efficient sediment dewatering of the geotextile tube. A higher volume pump with lower percent solids would have slowed down the process while waiting for the tube to dewater be-
