Taking the "Dred" Out of Dredging

The Project

Yorba Regional Park is a 175 acre day use park in Anaheim, California that accommodates well over one million visitors each year. The park was developed alongside the Santa Ana River with four small lakes connected by small streams and includes bike paths that connect to the nationally recognized Santa Ana River Trail that leads some 20 miles to the Pacific Ocean. A typical day at Yorba Park may include activities like fishing, boating, cy-

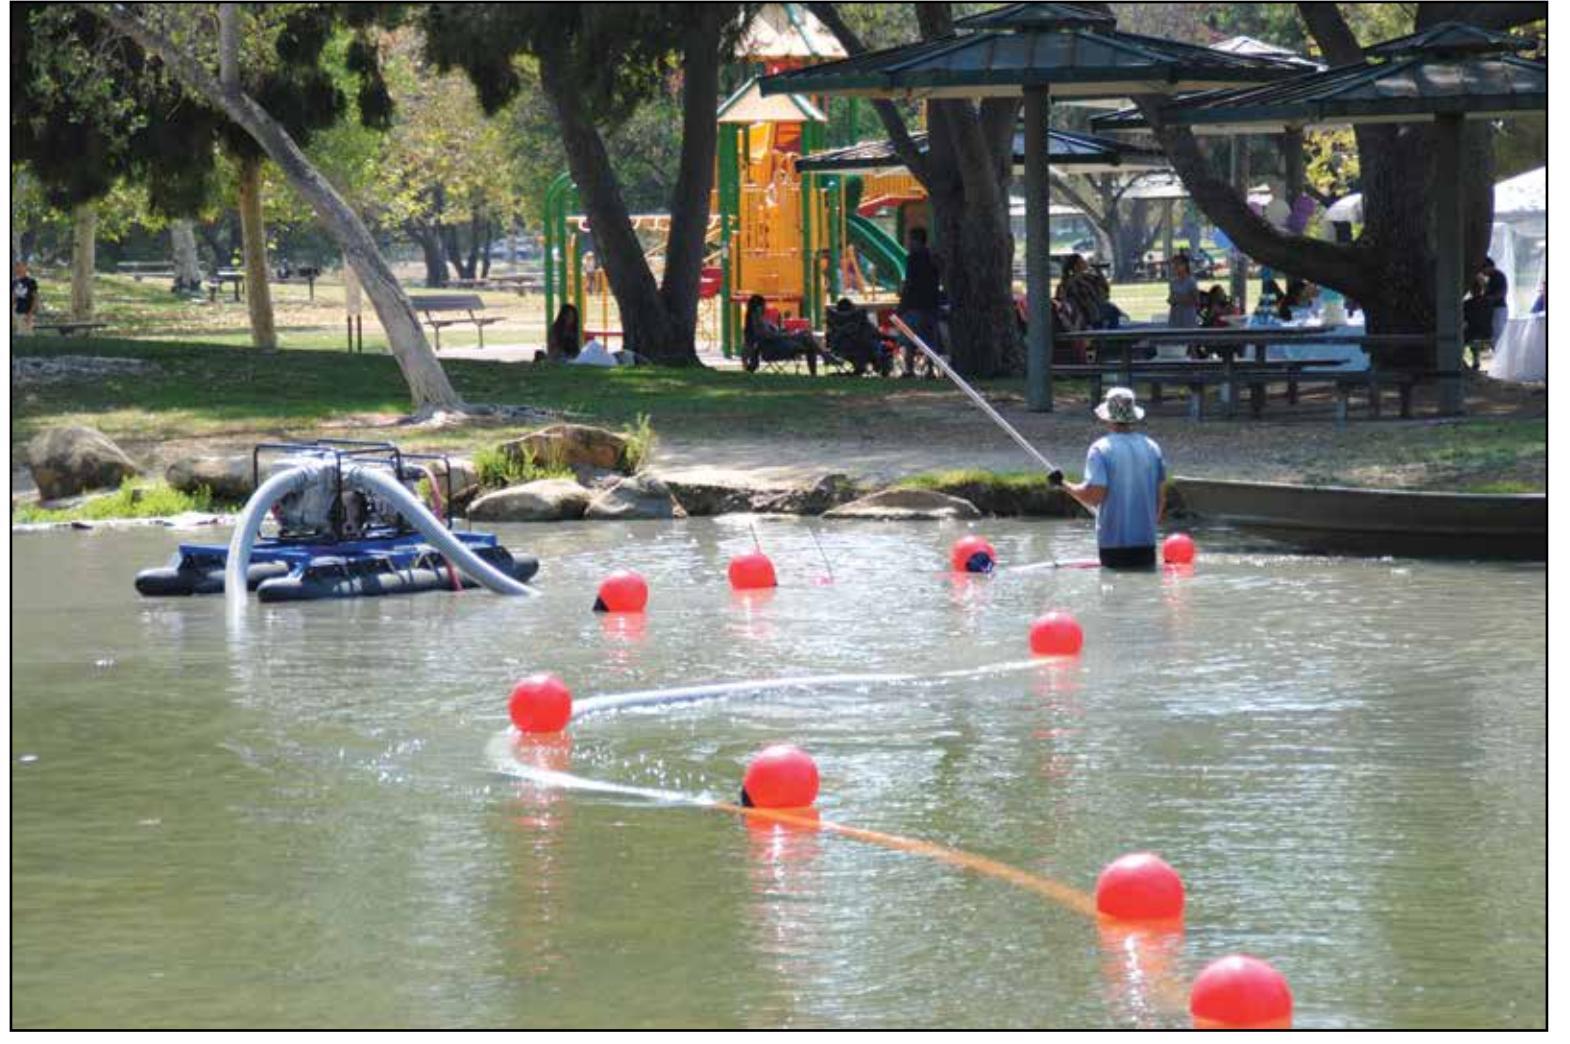
Working while daily park activities continue uninterrupted.

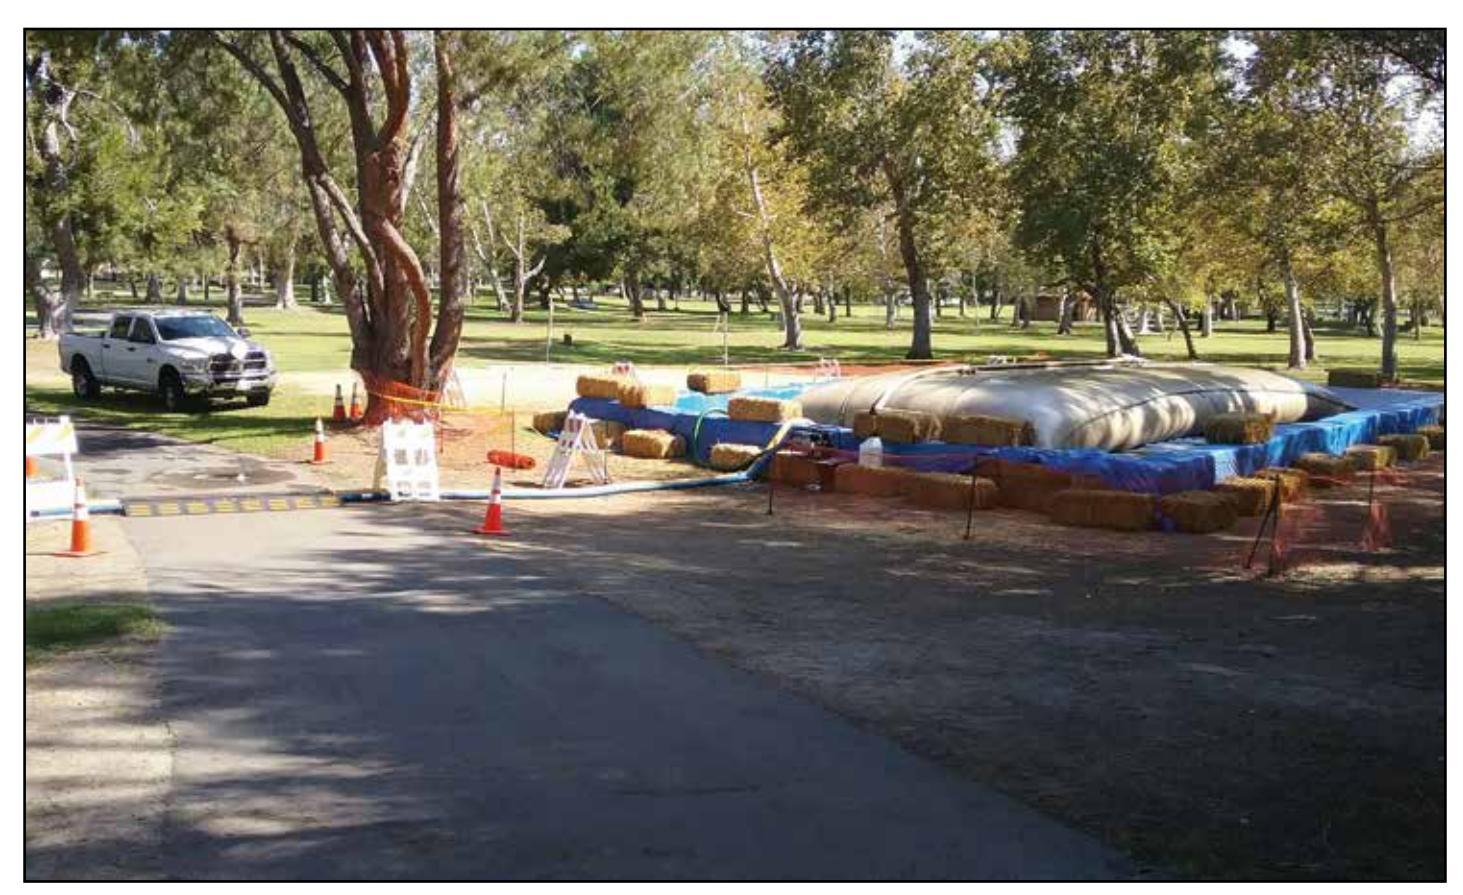
Temporary pipeline with bridges across the bicycle paths. Notice the volleyball court adjacent to the dewatering bag.

Using a temporary pipeline, the hand dredge system pumped the material across a heavily traveled pedestrian and bike path into a geo tube for dewatering. The decant water was contained and pumped back across the cart path to the lake. The noise level of the gas powered hand dredge system is also quite diminished in comparison to larger diesel powered hydraulic dredges, so there is minimal disturbance to park patrons and wildlife alike. During the project normal park activities continued as usual. A portable hose bridge was deployed to accommodate the dredge discharge and return water hoses so park visitors and employees could continue using the pedestrian and bike paths. Birthday parties continued uninterrupted, and a volleyball match was played next to the geo tube dewatering area. Even wildlife seemed undisturbed by the work in progress.

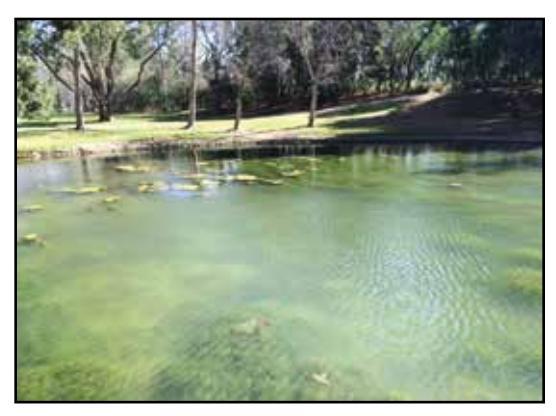
Chara and algae overgrowth.

water. The nutrient-rich, shallow water had become the perfect environment for invasive vegetation including algae and chara that may have been taking up as much as 50% of the lake bottom. Through a natural process referred to as eutrophication, a thick layer of "muck" – the remains of tree leaves, grass clippings and decayed aquatic plants – has quietly settled in the pond over the years. Decomposing material consumes oxygen, which is also in short supply at the bottom of the pond making it more difficult for fish and aquatic habitats to flour-

ish. And without oxygen, decomposition produces hydrogen sulfide and a rotten-egg smell which can cause complaints from park visitors. The pond muck also contains a high level of nitrogen, phosphorus and other nutrients that allow invasive aquatic plants such as chara to flourish. When sedimentation caused by eutrophication reaches this point, it often leads to a continuous cycle of chemical treatment to control the vegetation.

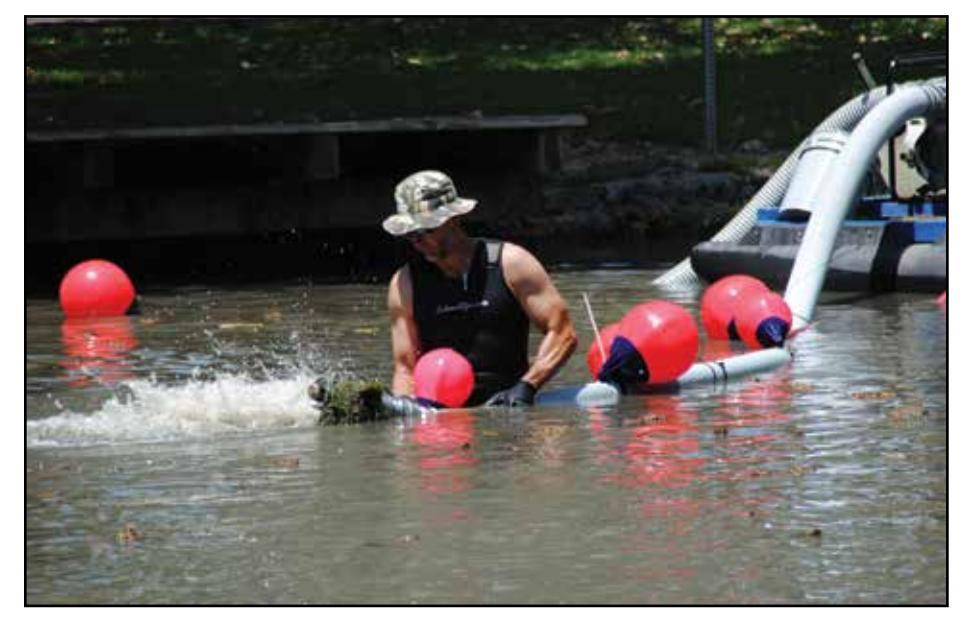
Above: Chara being removed from suction head. Left: Chara being removed by hand.

pump for hydro agitation. A suction head with 1.5 inch x 3-inch screen openings was used to prevent larger objects such as sticks, rocks and other debris from entering the suction hose and possibly damaging the pump. A pole was mounted to the suction head that allowed the operator to control the dredge depth while basically "vacuuming" the lake bottom. However, the chara that had consumed most of the lake bottom, posed a challenge for the small dredge. Chara would accumulate quickly around the suction head thereby "clogging the vacuum." To eliminate this

JW Faircloth & Son Inc. Hillsborough, NC 27278 | 919.732.1244 | 919.732.1266 fax condition, the chara was removed by hand which provided much better access to the silt and sediment accumulation.
